2 15
LIBBY DAM AND LAKE KOOCANUSA PROJECT, MONTANA

LEFT BANK SLOPE

REPORT DOCUMENTATION PAGE		READ INSTRUCTIONS BEFORE COMPLETING FORM
1. REPORT NUMBER	2. GOVT ACCESSION NO. AD A142 021	3. RECIPIENT'S CATALOG NUMBER
4. TITLE (and Subtitle) Libby Dam and Lake Koocanusa Project, Montana Left Bank Slope		5. TYPE OF REPORT & PERIOD COVERED Final

20. ABSTRACT (Continue on reverse side if necessary and identify by block number) Report details the geology and history of the Libby Left Bank Slope instrumentation program, presents plots of instrumental data for the period 1967-1983 and provides a technical evaluation of the present status of the slope.

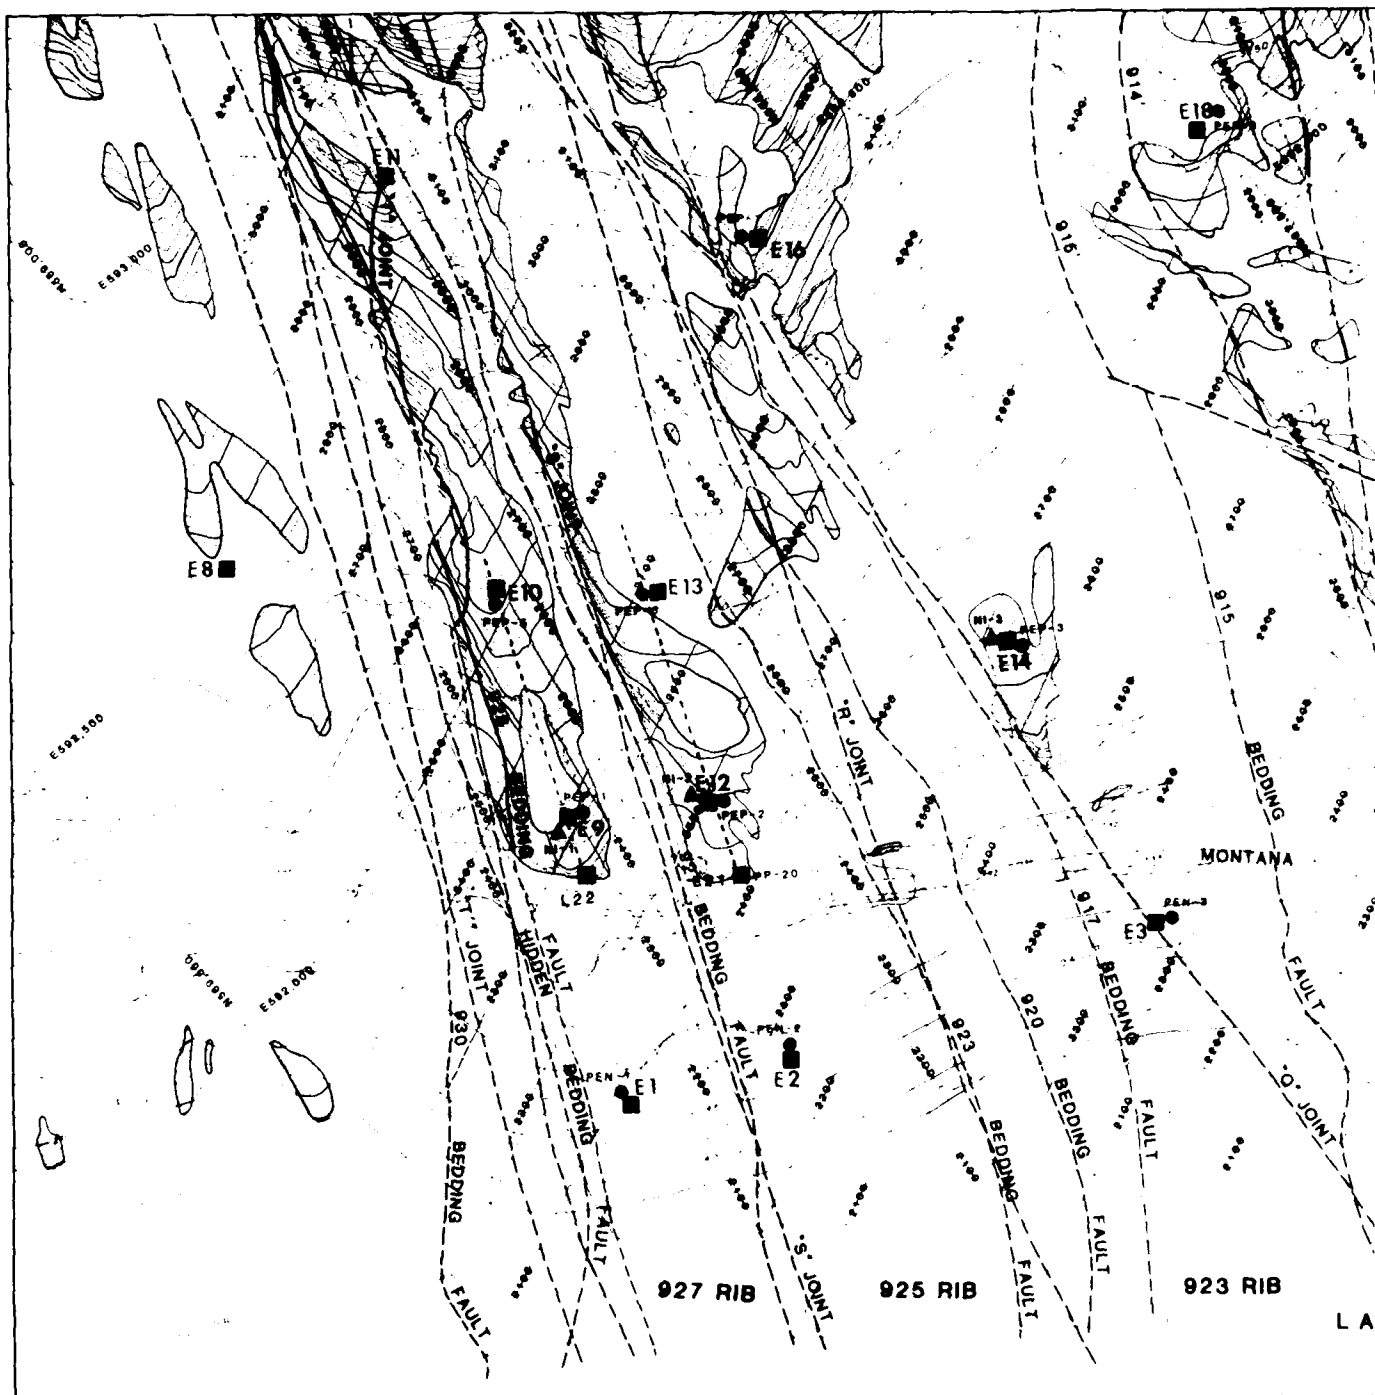
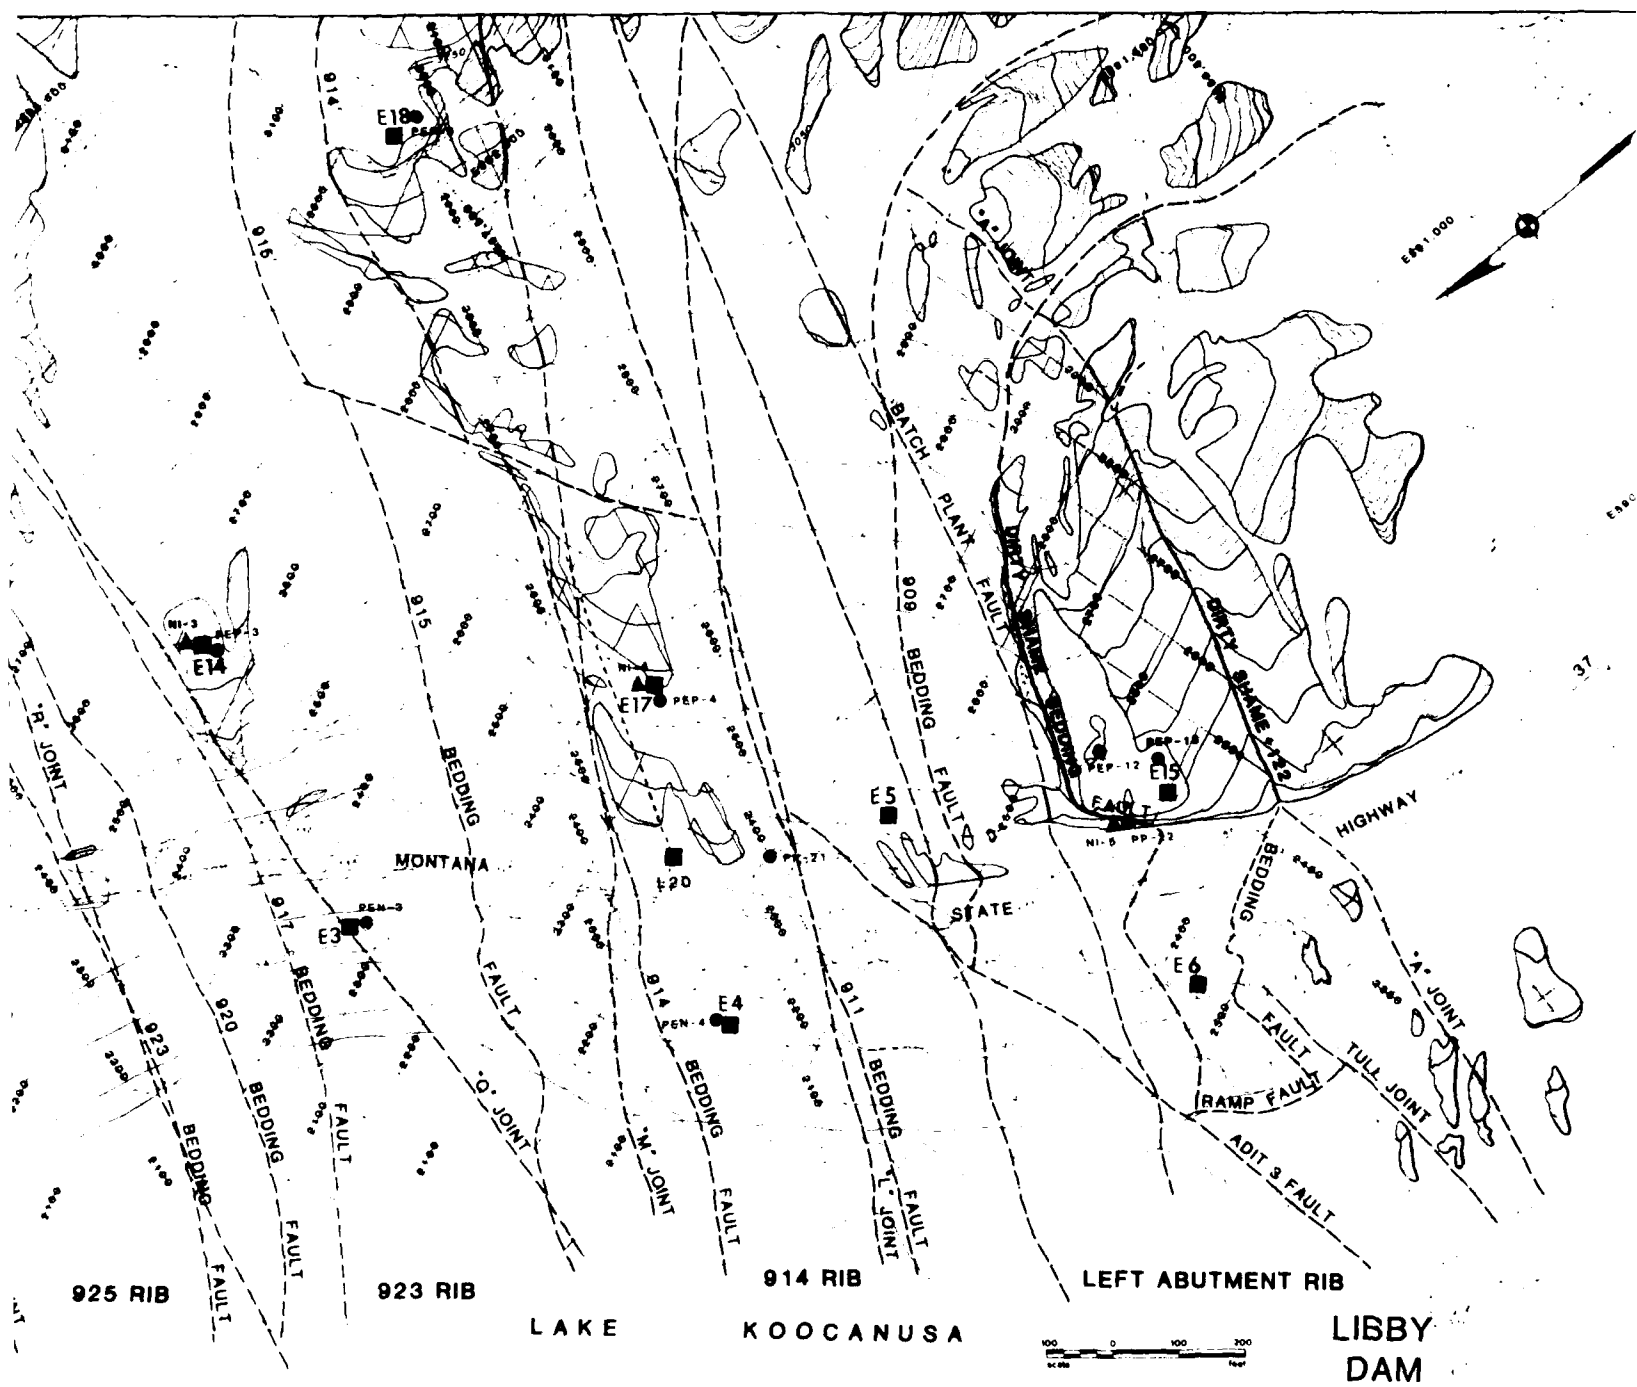
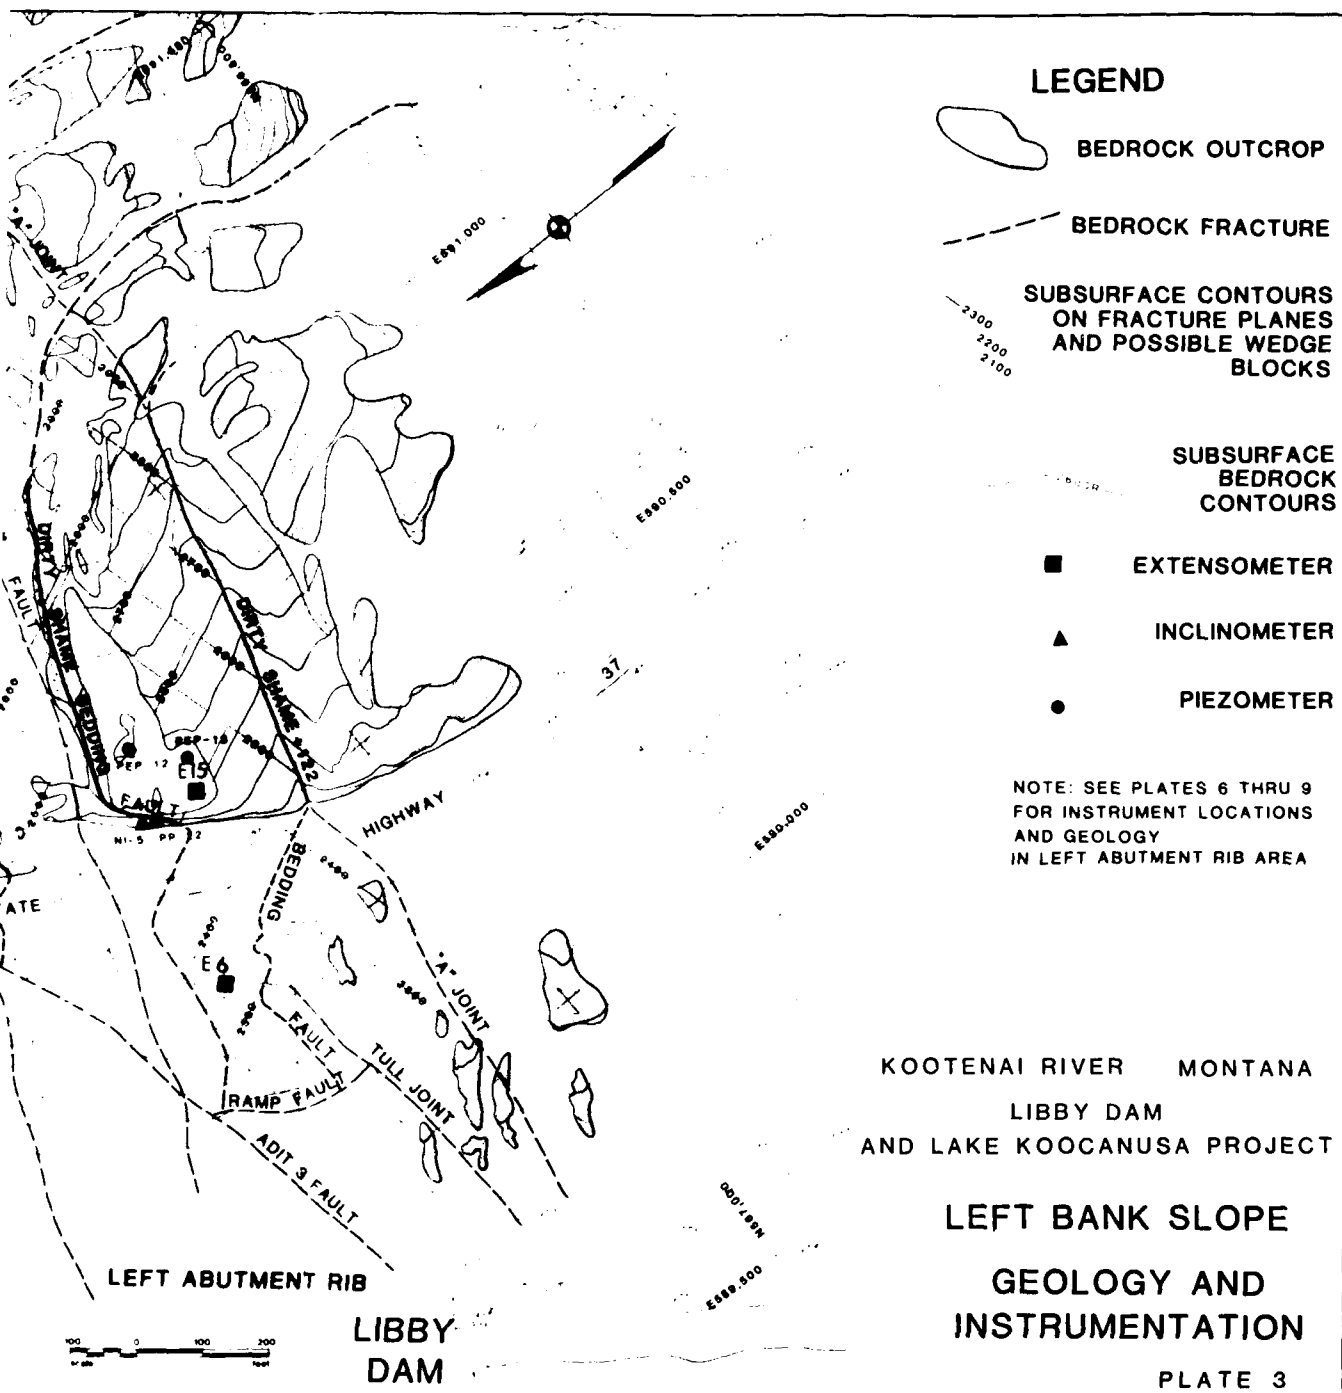
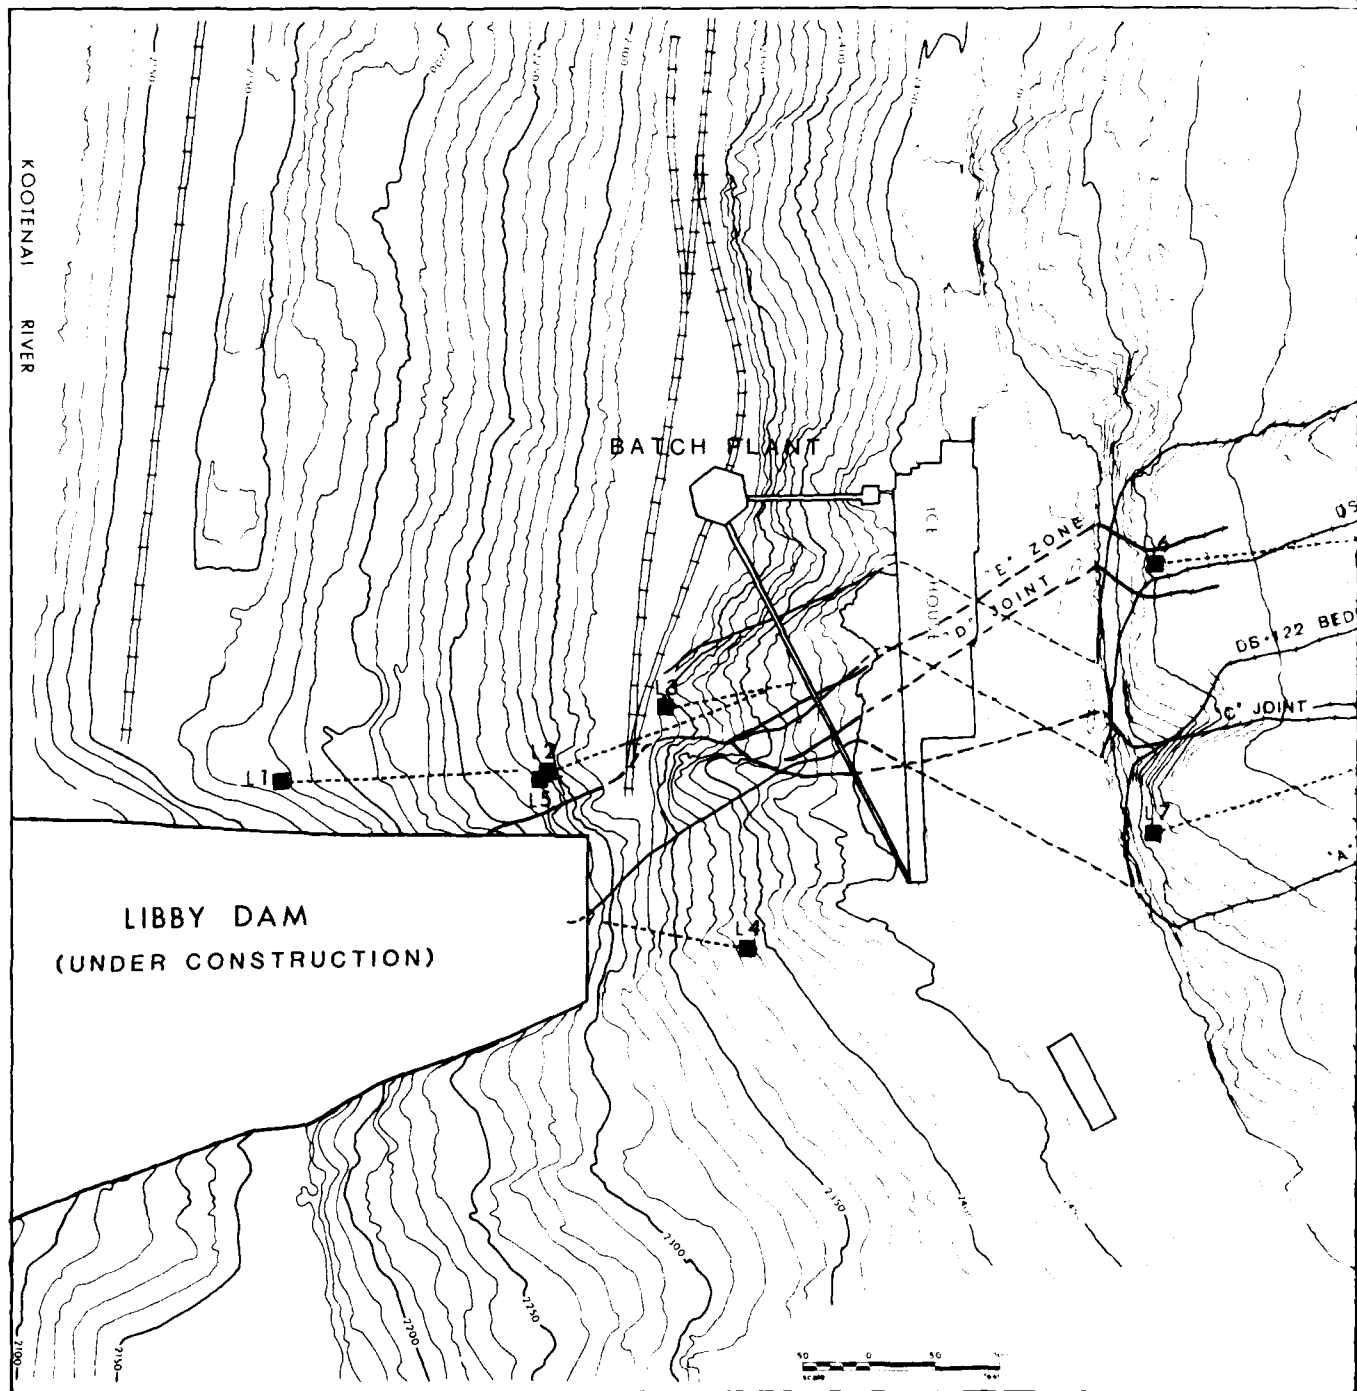
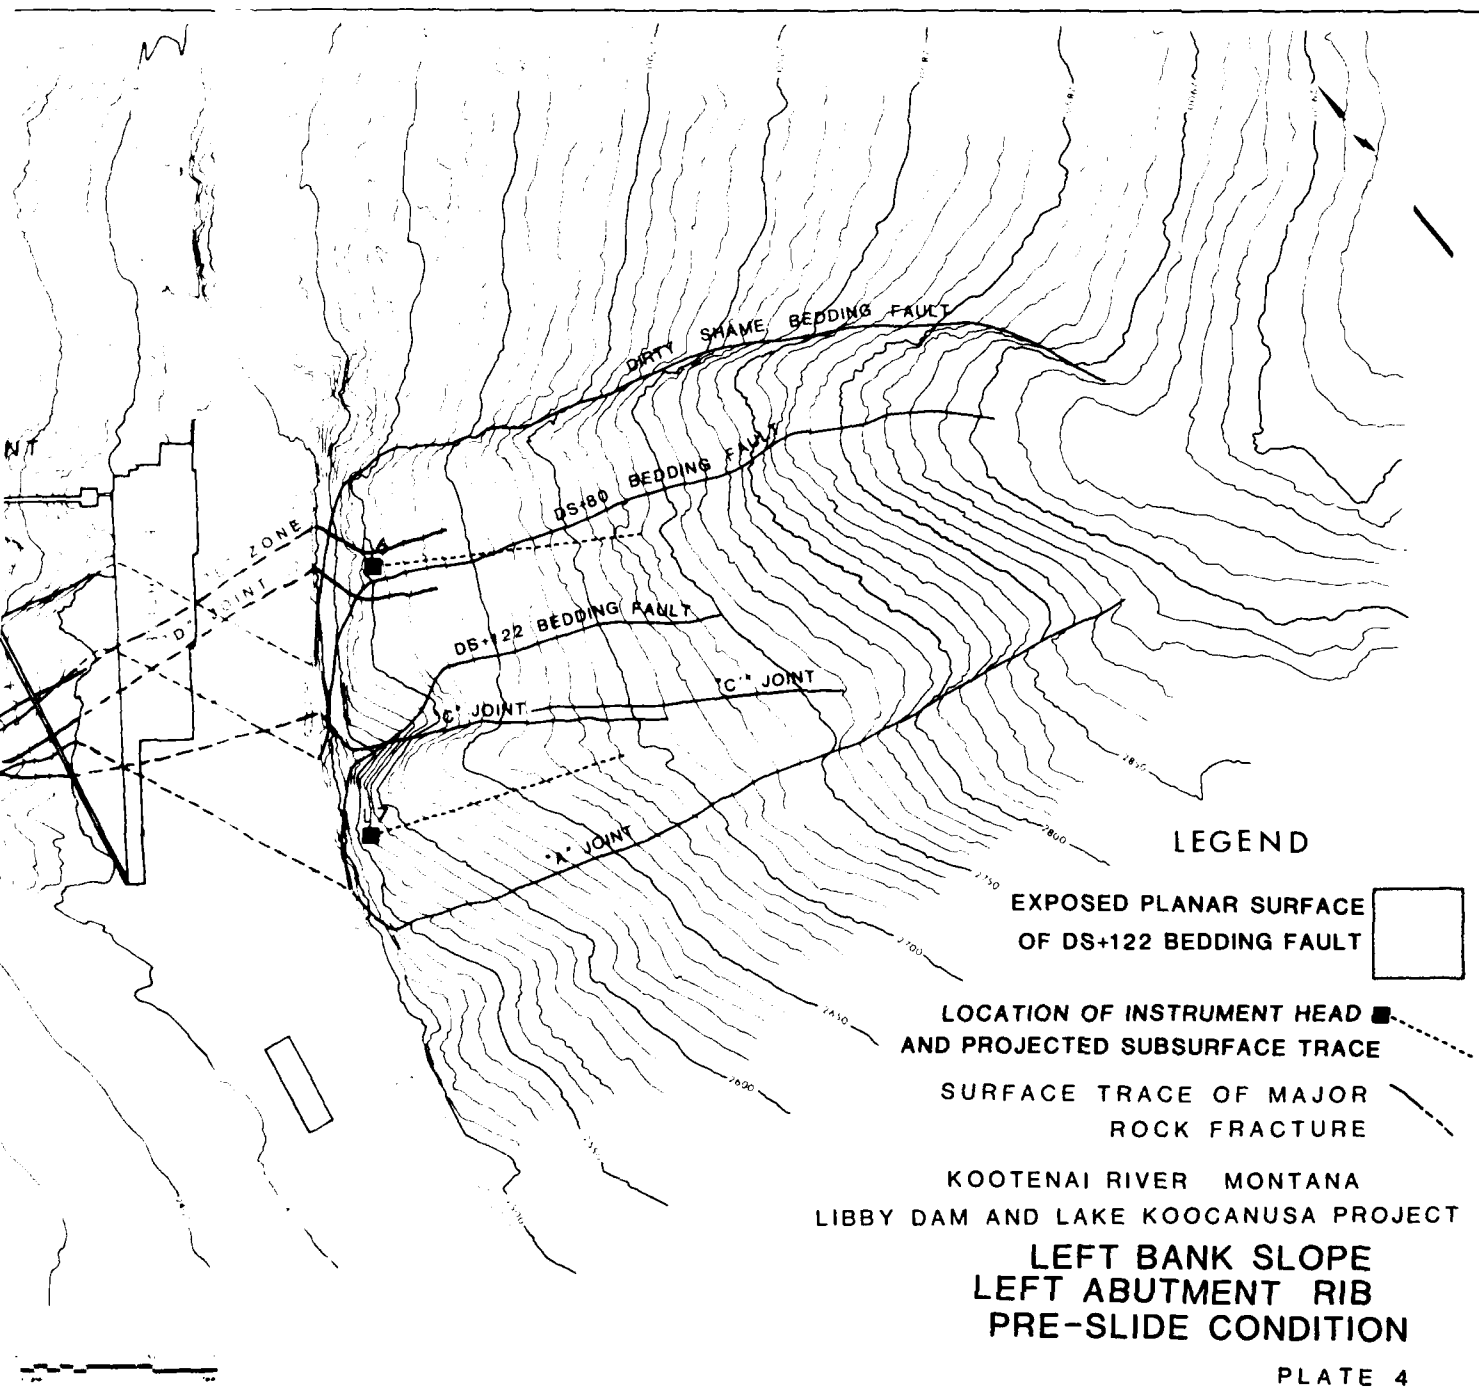
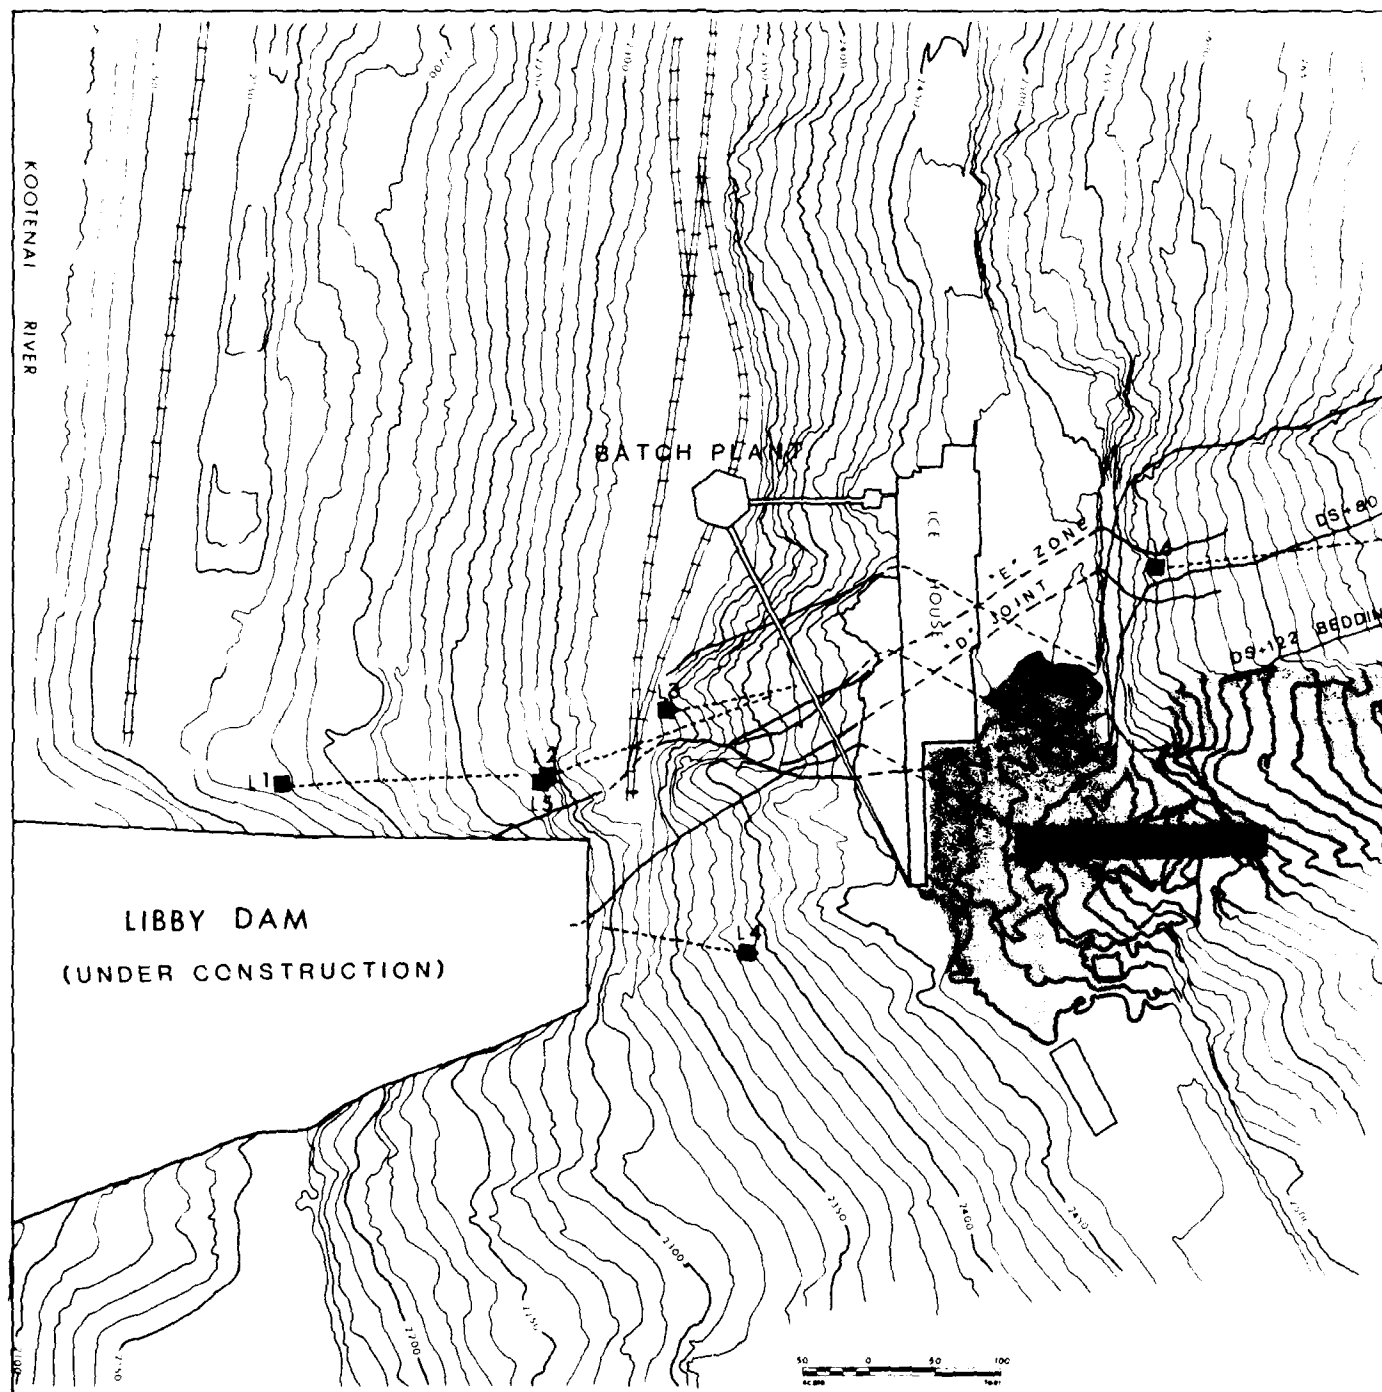
PLATE 6

to the C Prime Joint. A North-South Tension Joint is exposed as a series of en echelon cracks across the face of the DS+l22 from the C Prime Joint (plate 6). While such joints generally exhibit a lack of continuity, this one appears to extend to some depth below the DS. The feature appears to strike about N10E and dip 58-60 degrees east into the slope. There is no evidence to suggest that this joint extends upstream of the D Joint or downstream of the C Prime Joint. An upper north-south to northeast trending joint zone is present high on the upper slope generally between elevations 2,700 and 2,750 feet. The zone is a complex of joints striking N10E to N50E generally dipping east into the slope about 60 degrees. A gentle river dip joint in this zone forms a narrow ledge across the exposed face of the DS+l22 between L-11 and north of L-16 to the crest of the rib. The zone marks the downslope limit of the "pluckout" between A and C joints.

(7) North-South Tension Joint (Figure 4.10, Plate 6). The North-South Tension Joint which is exposed as a series of en echelon cracks across the face of the DS+122 upstream from the C Prime Joint and downstream from the D Joint is monitored by X-5 and X-6 at shallow depths. Both instruments have reflected cyclic thermal expansion and contraction of the joint since instrument installation late in 1976, with borehole extension peaking in late winter (joint expansion, rock mass contraction) and borehole compression peaking in the fall (joint compression, rock mass expansion). Of greater concern, however, is the extension indicated across what is interpreted to be the same north-south joint in L-13 at the toe of the cut below the DS. Extension began on this zone about 120 feet behind the toe of the face late in 1981 and continued in step form through 1982. The extension was quiescent during the first half of 1983, beginning again in July. Total extension observed about 0.1 inch since late 1981. This tension joint exhibited signs of opening late in 1975, which prompted installation of the face tendons the following year. The deeper strain is suggestive of movement of block bounded by the C Joint, North-South Tension Joint, and an undefined bedding fault below the DS but above the 909. The lower portion of such a block would be buttressed by the rock mass between the dam abutment and the toe of the cut, but a large toppling failure would be possible.

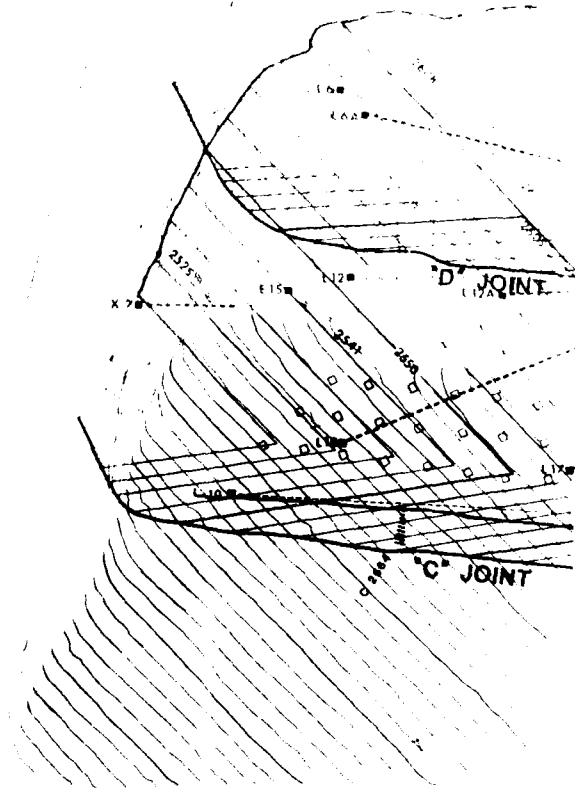
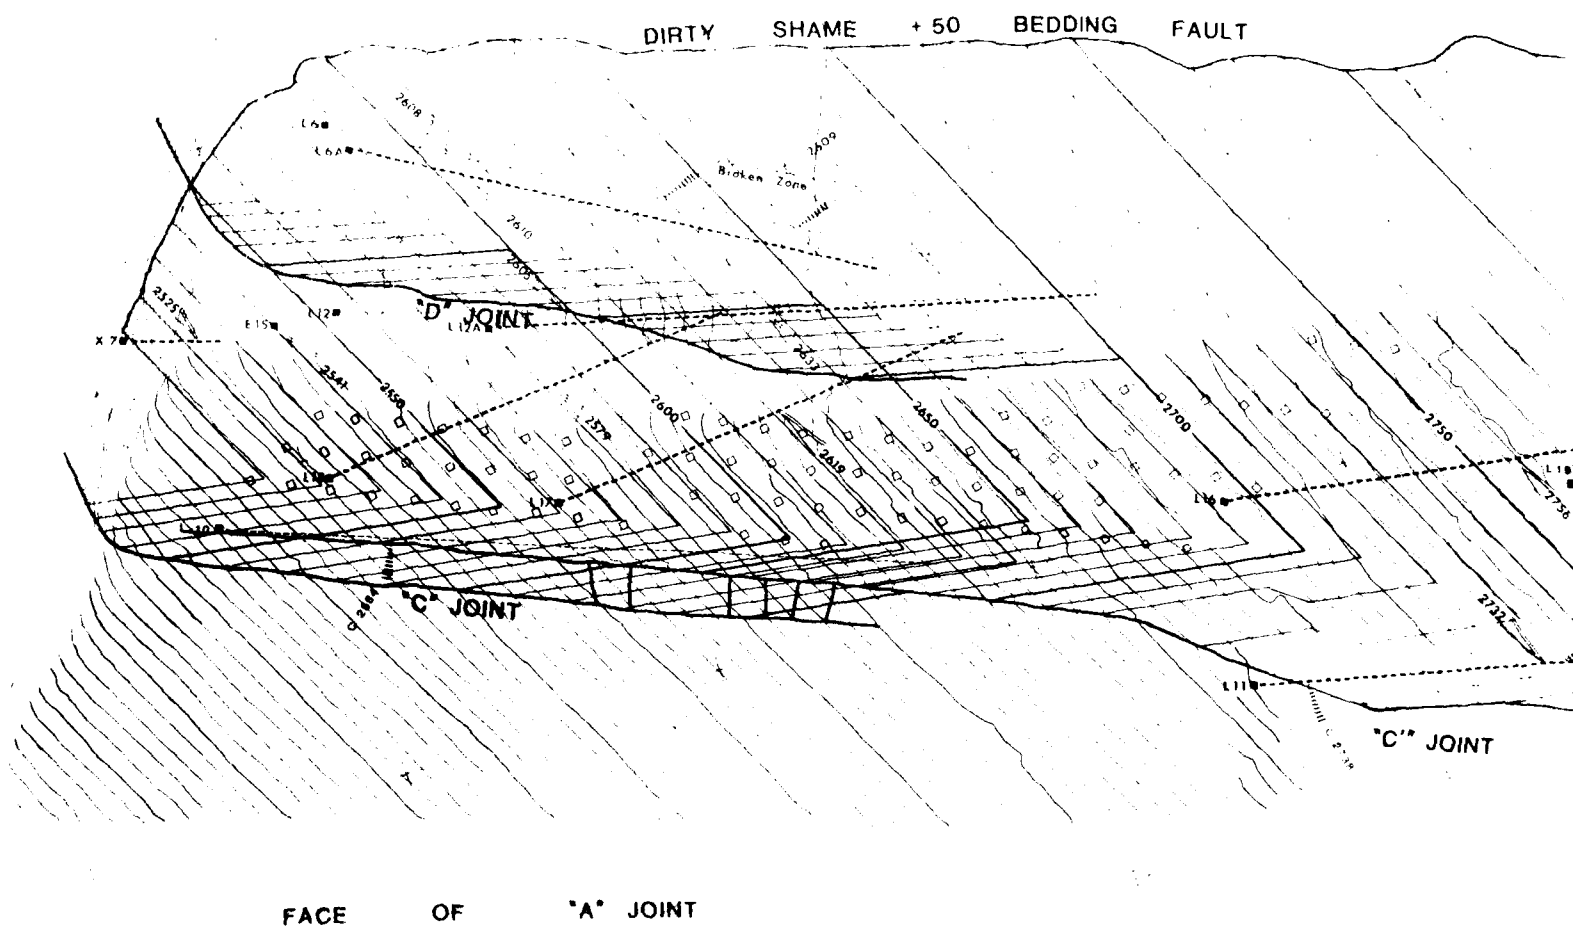
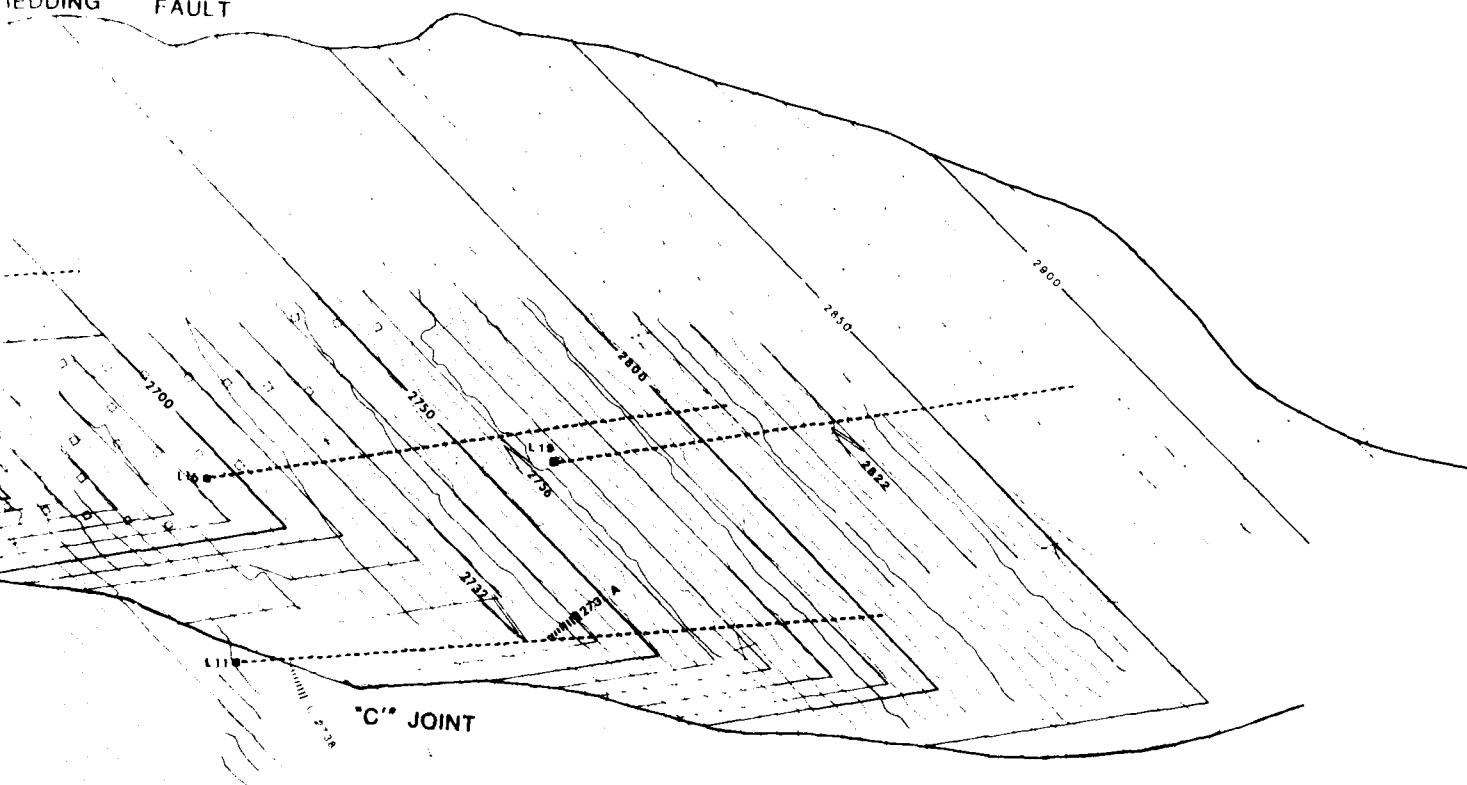
PLATE 8

(2) Dirty Shame+50 (Figure 4.5, Plate 8). Adjustments across the DS+50 tend to be confusing, but total recorded movements are small. High on the slope, the anomalous compression across this fault, registered on L-16 during the late 1970's, appeared more indicative of stress from below the fault plane than from above. Late in 1979 and early in 1980, nearly 0.1-inch extension was indicated which has subsequently fluctuated seasonally, the most recent extension late in 1982. This movement arrested early in 1983. Contrariwise, L-11 and L-12A suggested that essentially the opposite was happening. Low on the slope, E-15 suggests a stepped downslope movement aggregating 0.1 inch in the last 8 years; however, X-7 on the face confirms less than 0.02-inch compression since the beginning of 1979. Overall, these adjustments do not appear to be indicative of significant movements.

LEFT BANK SLOPE
LEFT ABUTMENT RIB
DIRTY SHAME+50/C-C'
BLOCK AND
ASSOCIATED BLOCKS

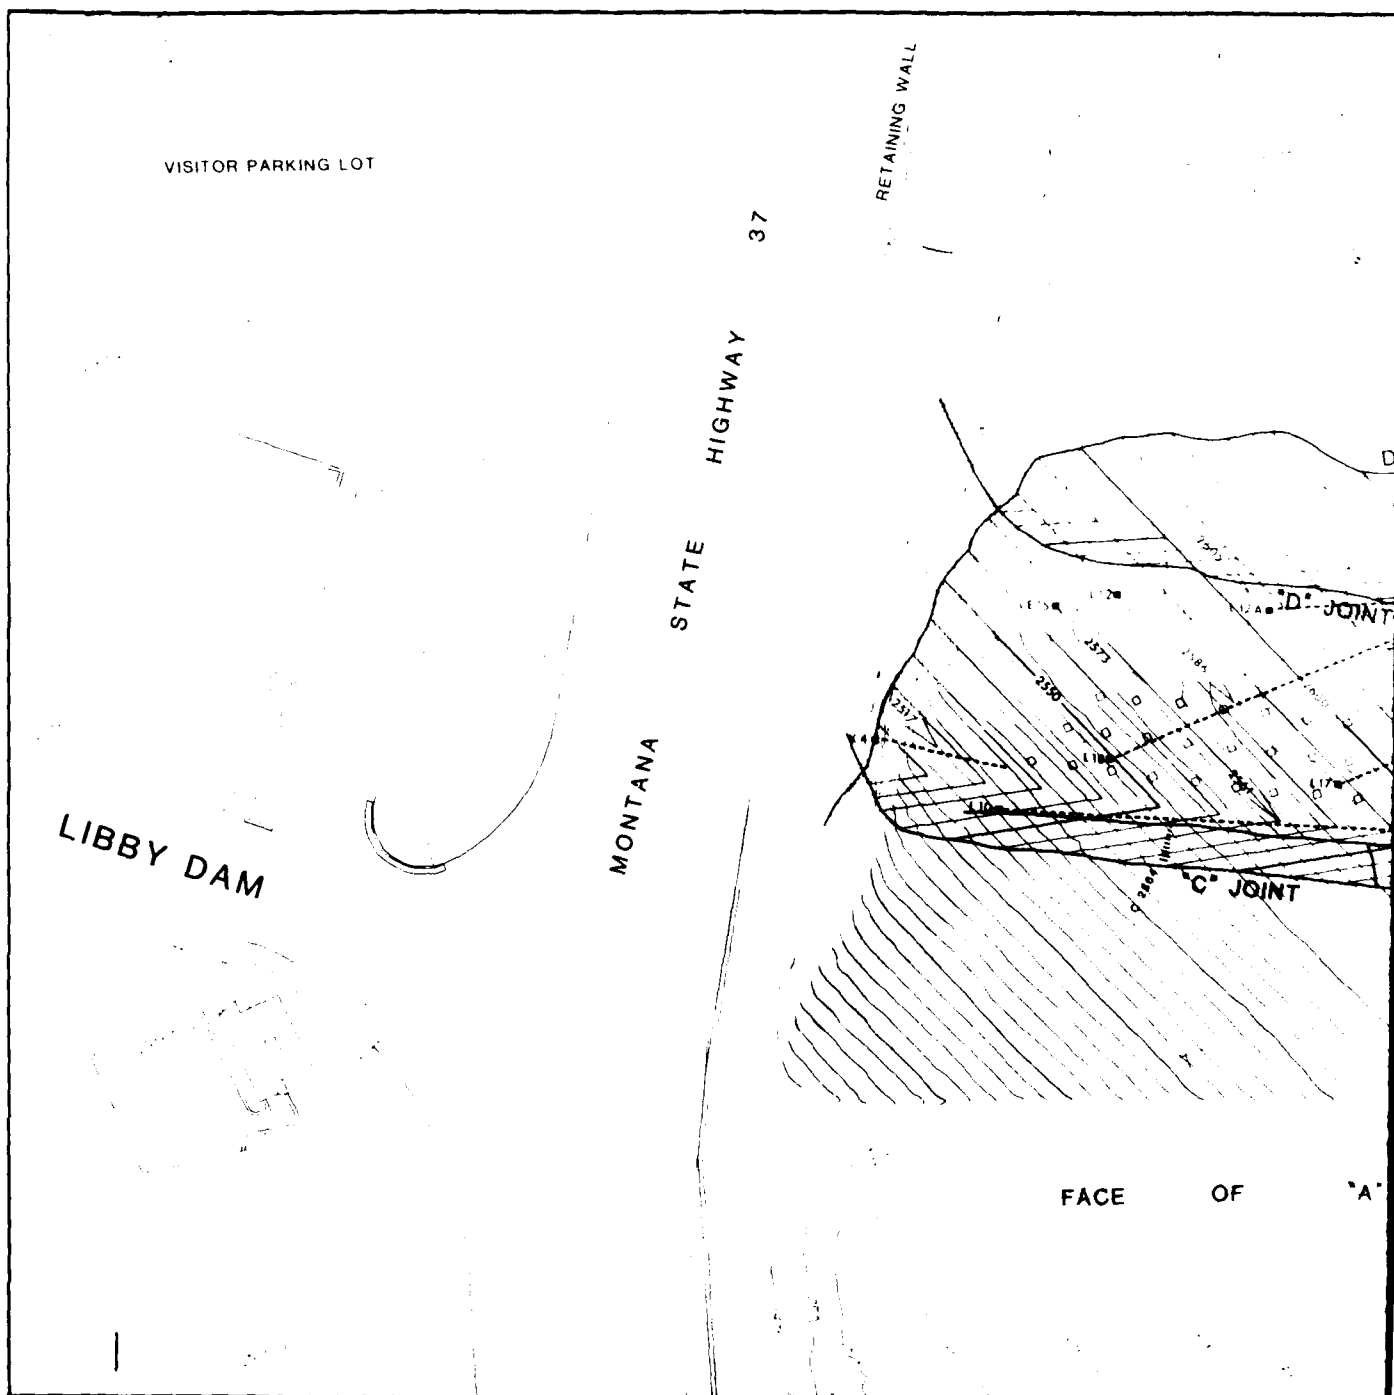
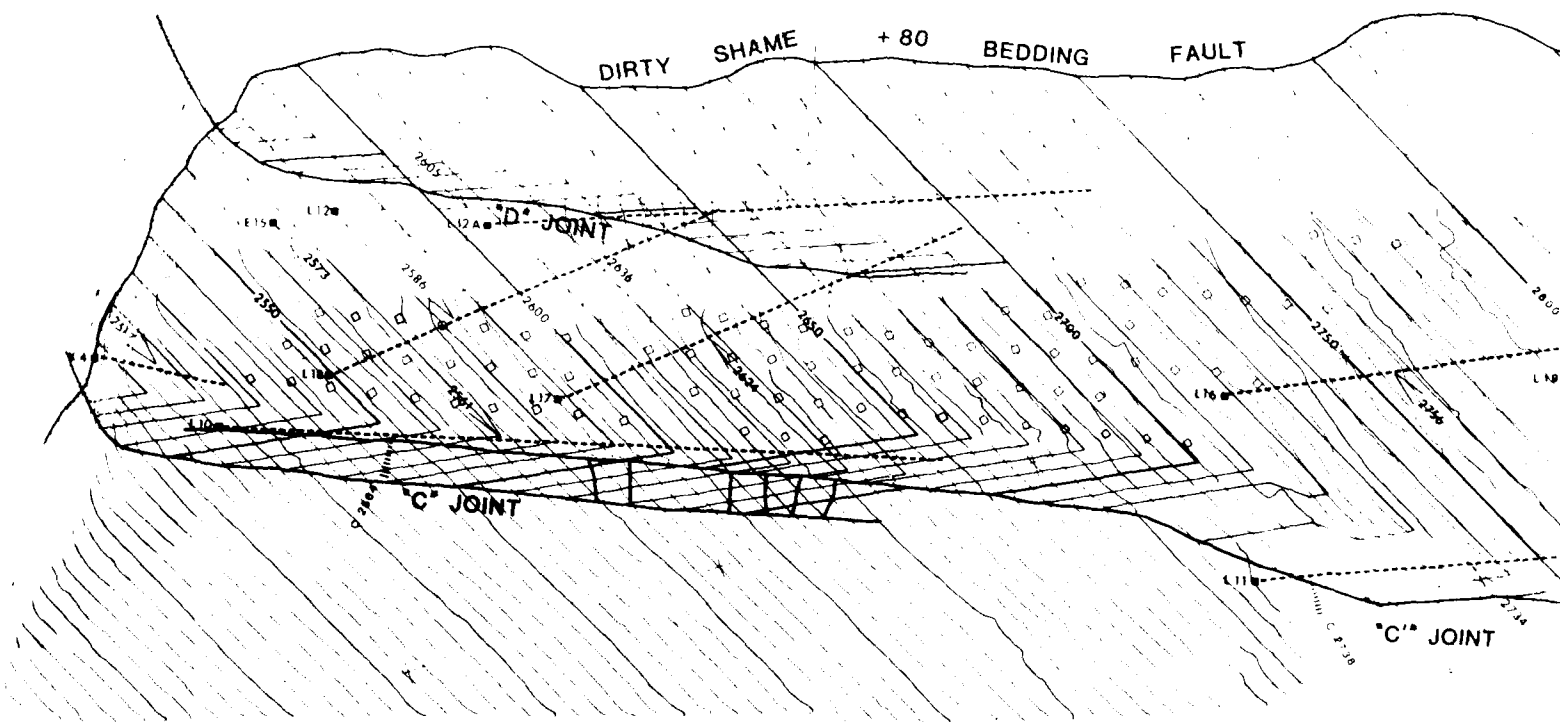
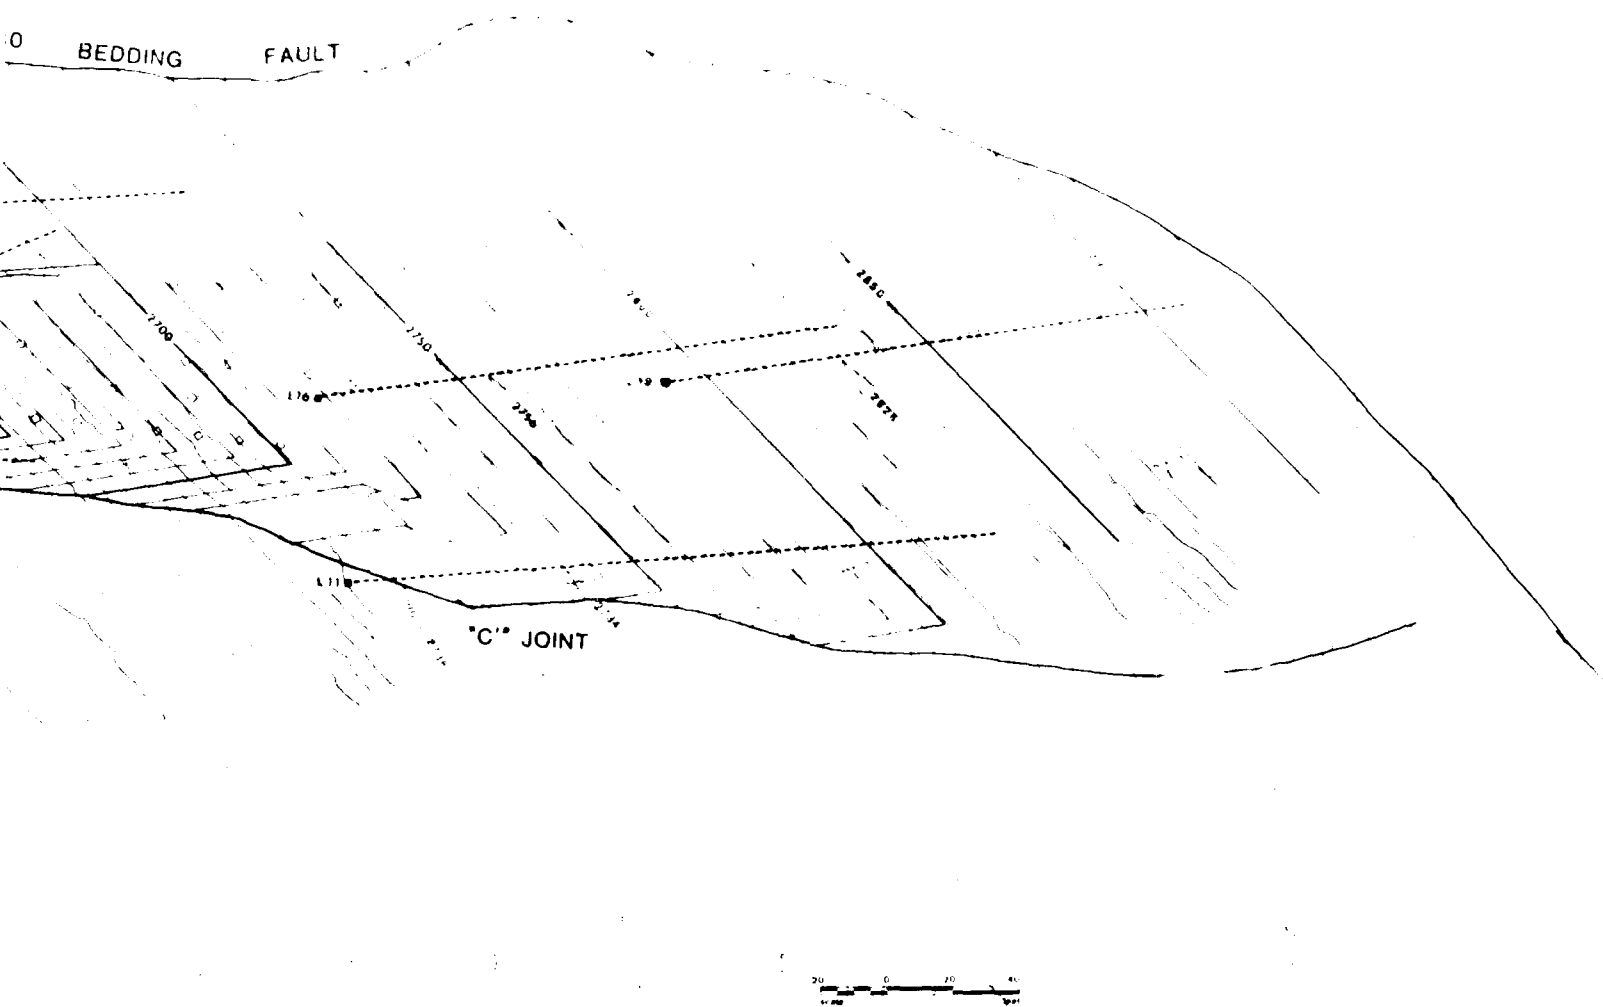
PLATE 9

(3) Dirty Shame+80 (Figure 4.6, Plate 9). Three instruments (L-11, L-12A, and X-4) show a remarkably consistent cyclic change across the DS+80 with a midwinter extension peak and a midsummer compression trough. There is a consistent long-term trend into extension, however. The movement was first detected at the face (X-4) in mid-1975 and high on the slope by mid-1979 on L-11. The magnitude of the annual cyclic "noise" fluctuation is on the order of 0.05 inch. Overall, total motions on the order of 0.38 inch at the cut face and 0.18 inch higher on the slope are indicated. Since late 1979, the three sensors have shown on the order of 0.1-inch extension. However, only a slight bit (0.04 inch) of long-term extensional creep has been registered by L-16 across the DS+80 which is inconsistent with the data from L-11. Low on the slope E-15-4 registers no significant change. Downstream from the C Joint 0.04 inch extension occurred across the DS+80 late in December 1983 but had stabilized by January 1984 (L-10, appendix B). This apparent DS+80 movement may be related to C-C Prime system however.

LEFT BANK SLOPE
LEFT ABUTMENT RIB
DIRTY SHAME+80/C-C'
BLOCK AND
ASSOCIATED BLOCKS
